The last flight of *Texas* *Tornado*

Robert Brassey
Principal Specialist Cultural Heritage

Flying fortress crash site

USAAF B17E Flying Fortress 9 June 1942

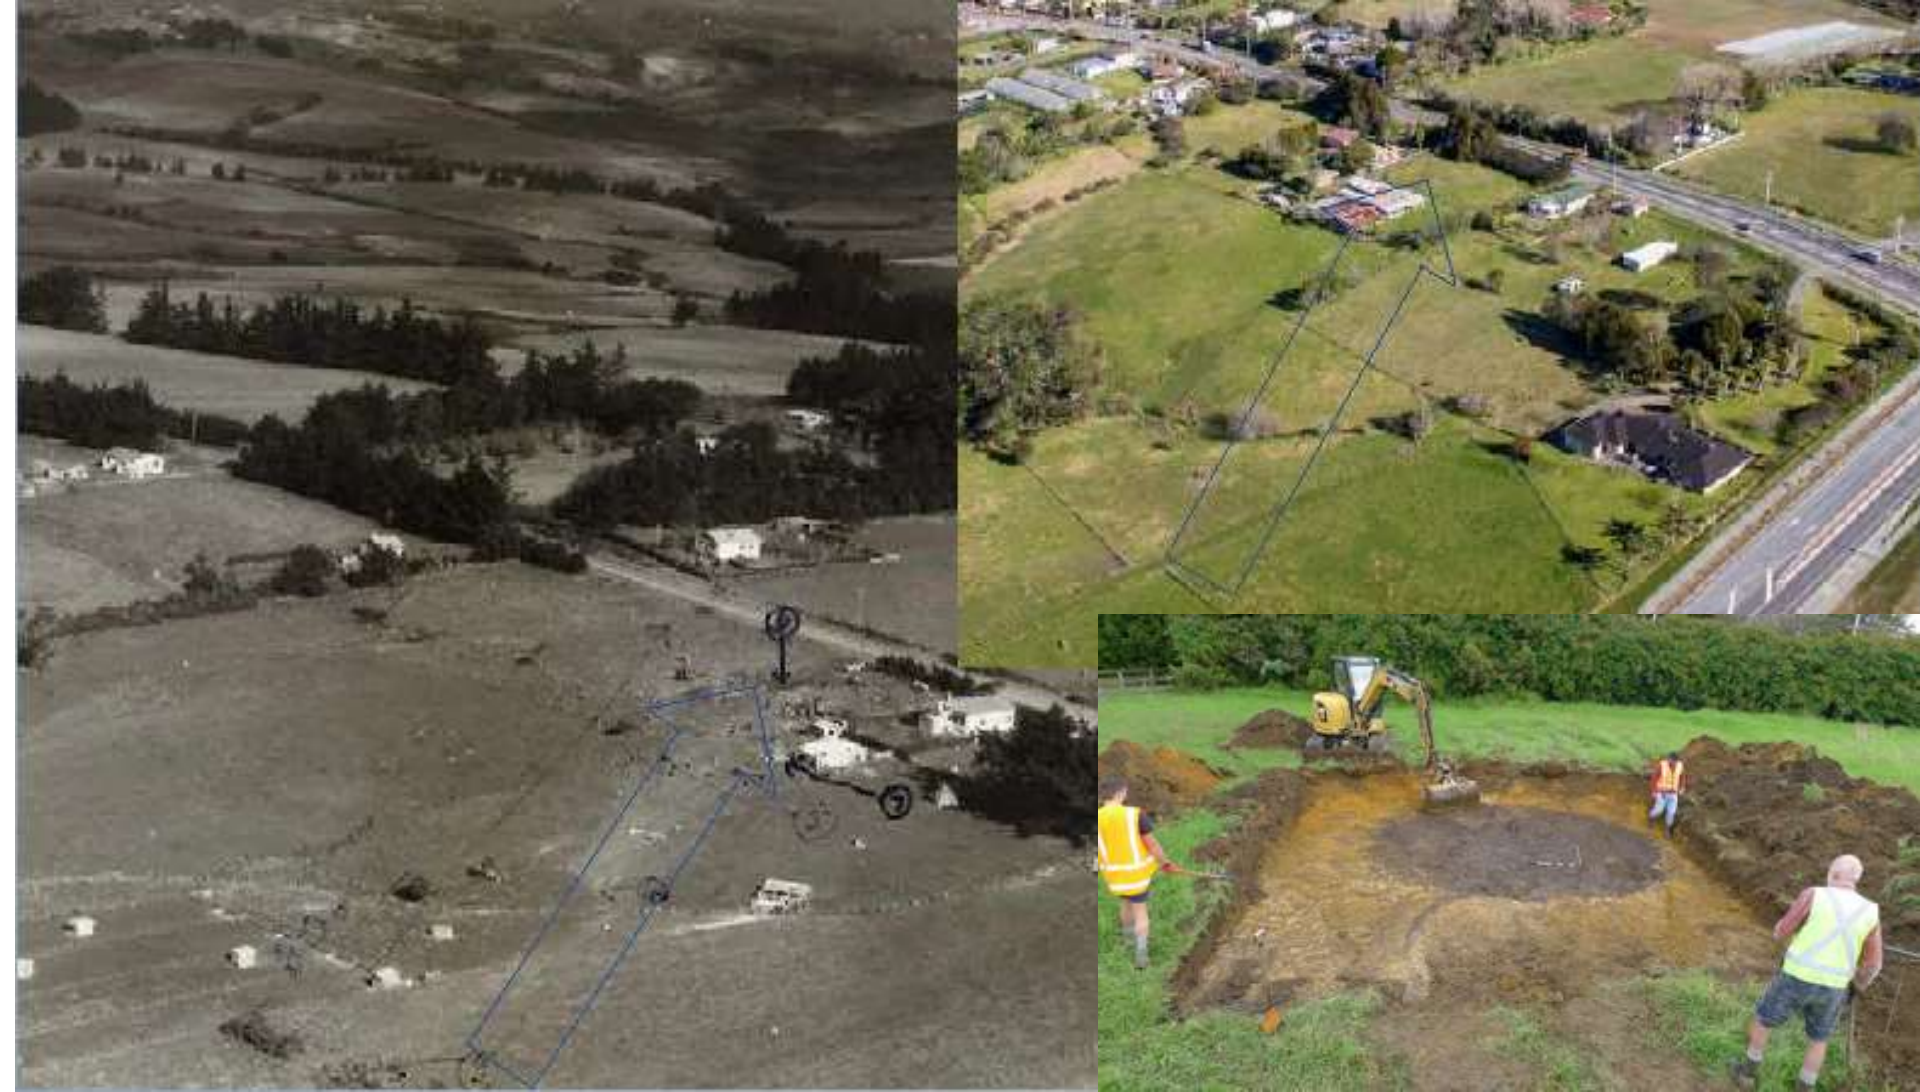
Infilled crater located by ortho-rectification of aerials, probing and test pitting

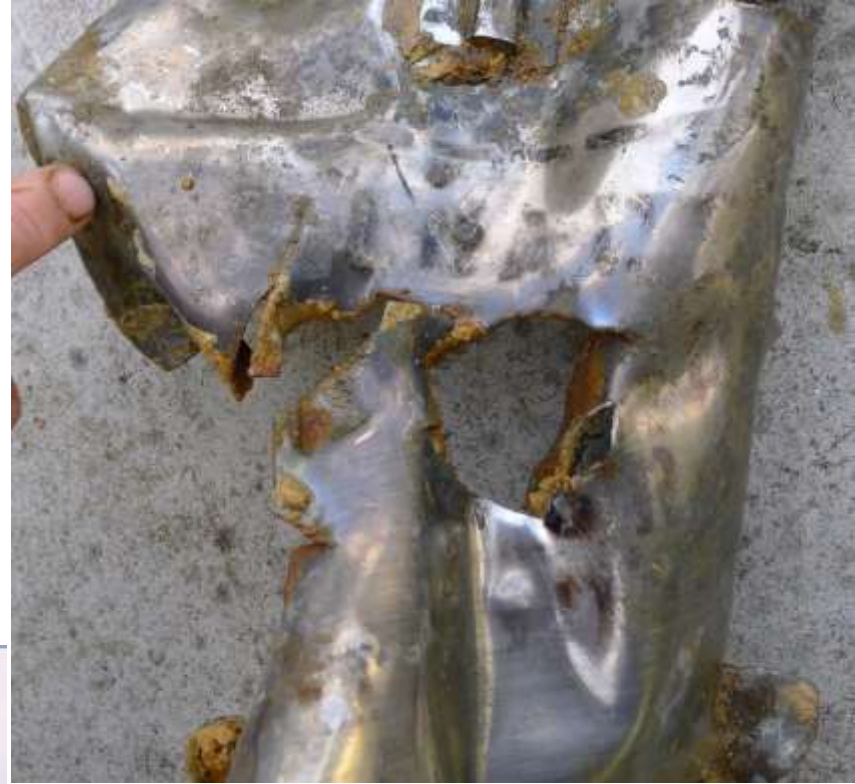
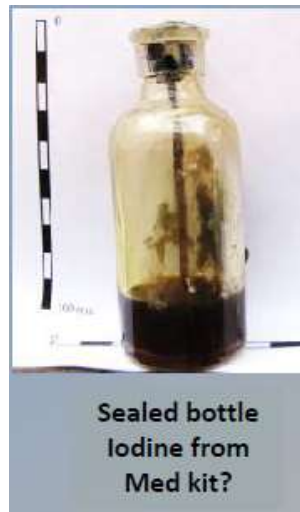
Sealed bottle
Iodine from
Med kit?

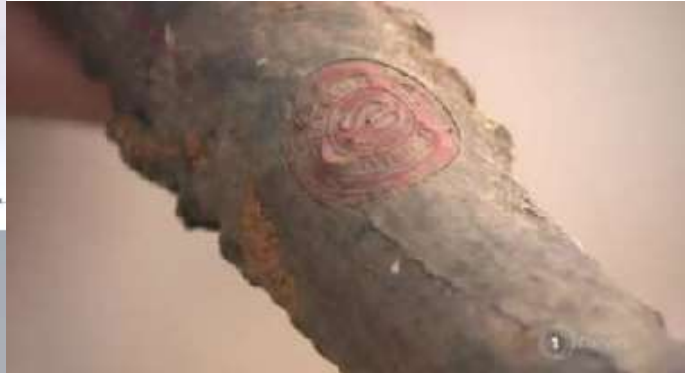
Ammunition – lots, but all had exploded during the fire

Mostly heavy machine gun;
also light machine gun & side
arm calibres

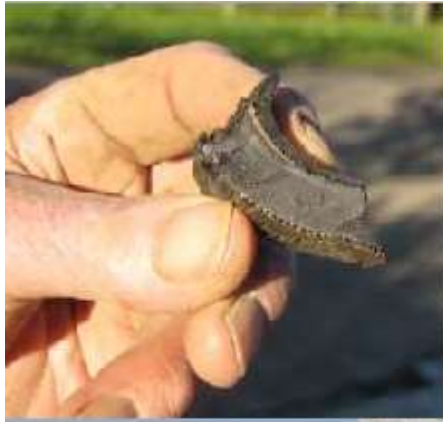
Bullet/puncture
-proof rubber
fuel tank (burnt
remains)

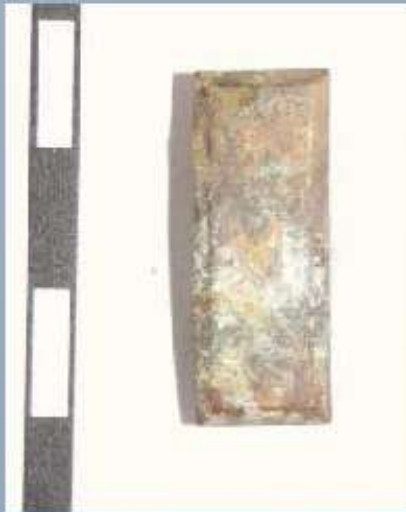
Lieutenant's Bar
(Navigator?)

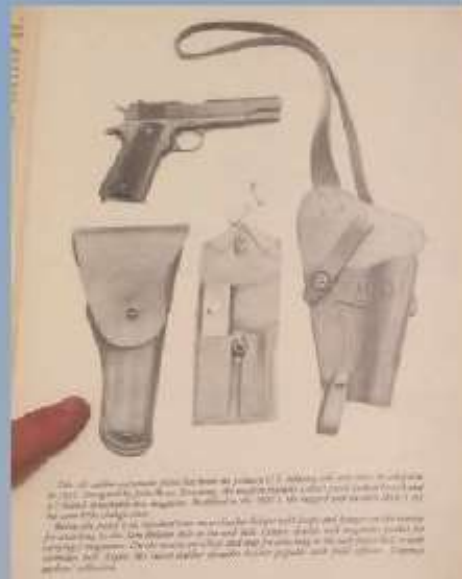
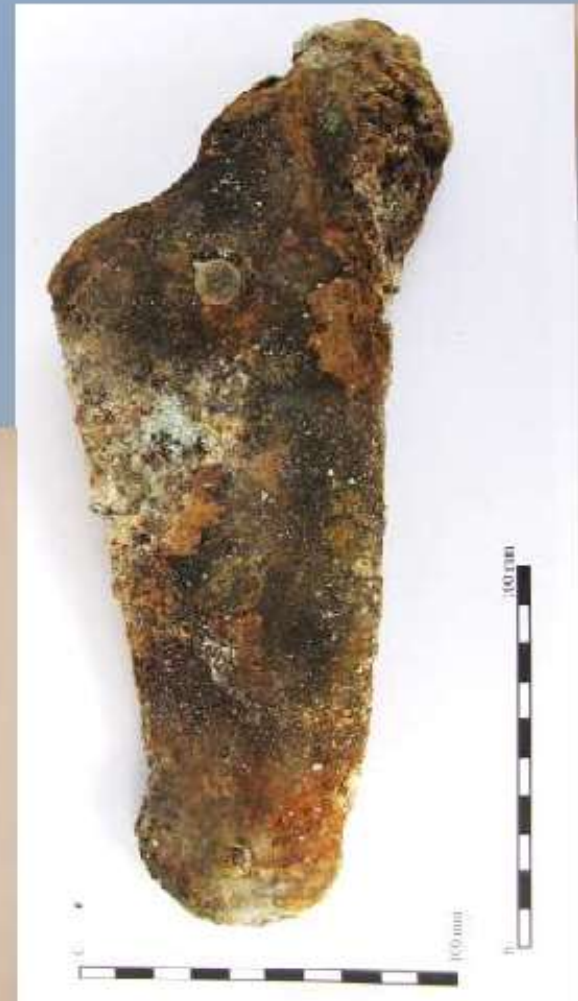
Sidearm Holster
(Front Cover) Left?

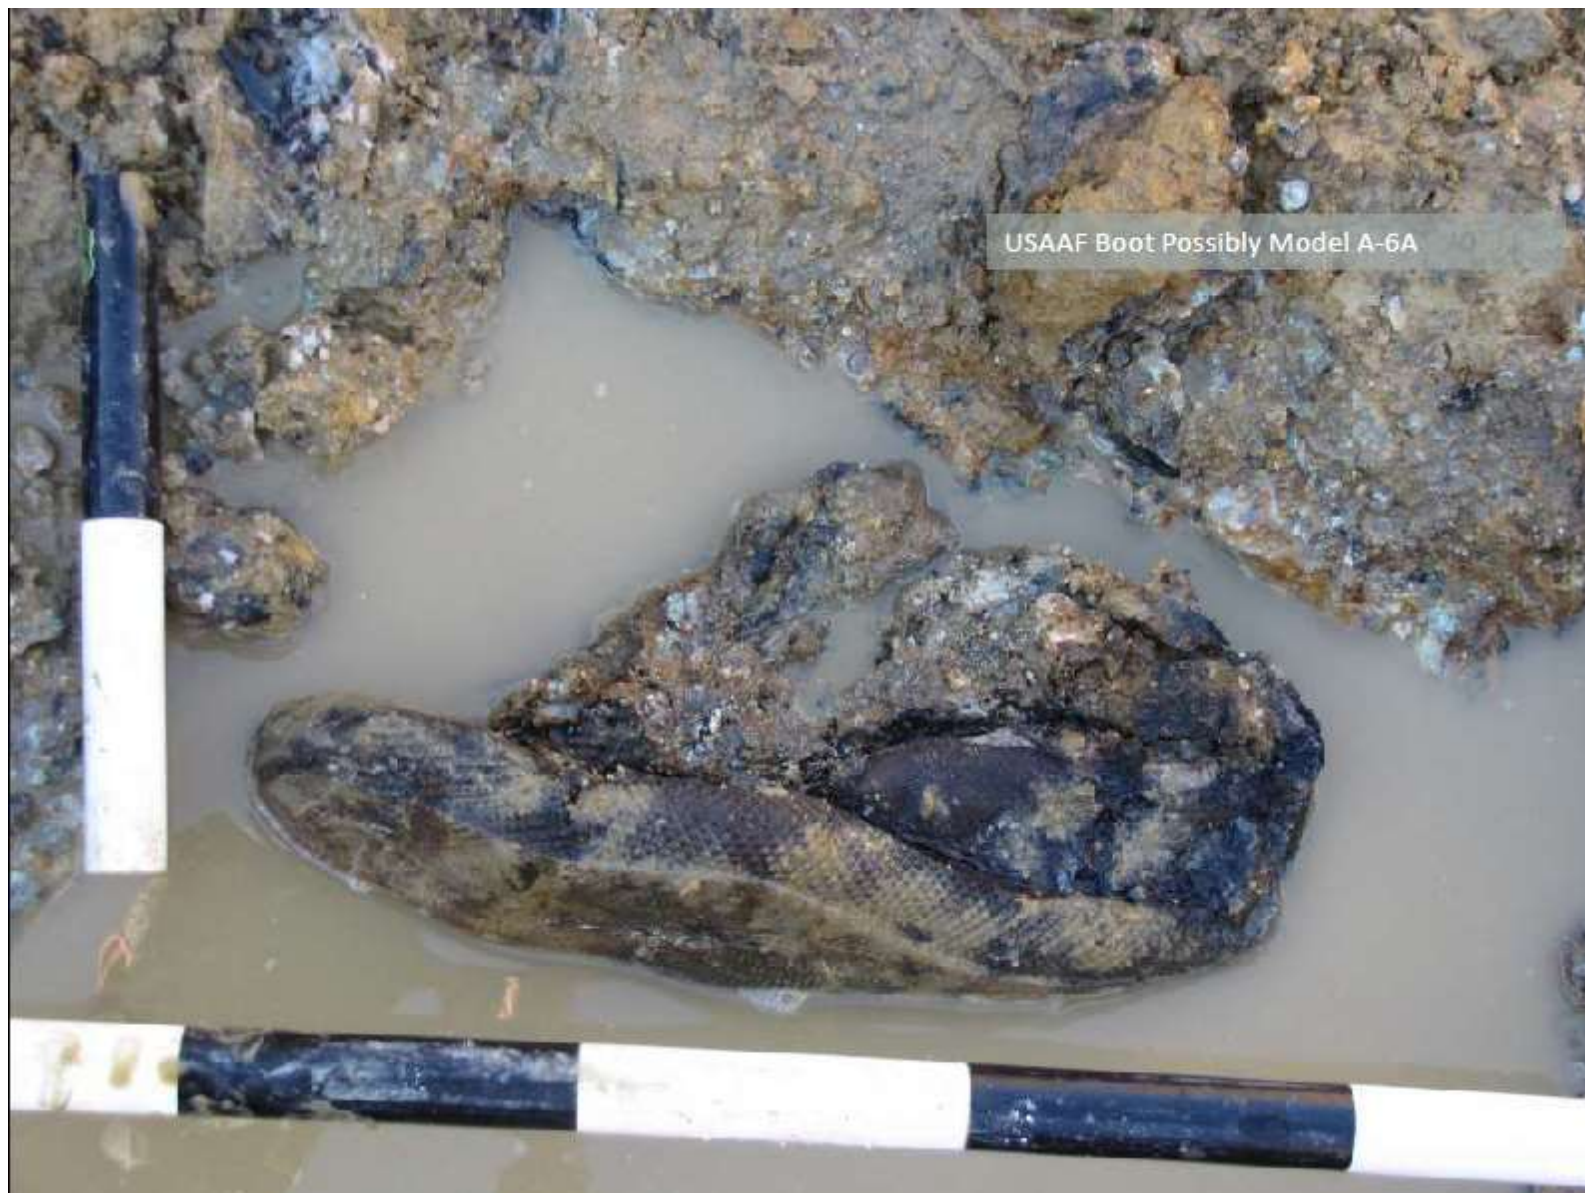
USAAF Boot Possibly Model A-6A

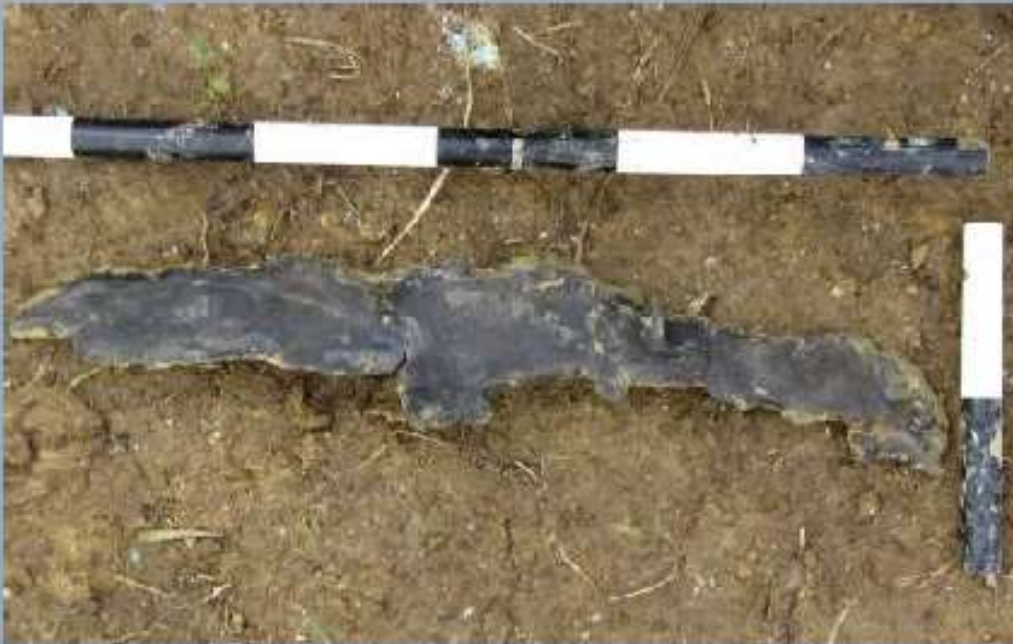
- Bomb Fragments at bottom of crater
- Number engraved '..36B6'
- Possible model AN/M43?
